NASA CR-135078 R76AEG461

FIBER COMPOSITE FAN BLADE IMPACT IMPROVEMENT PROGRAM Final Report

T.L. Oller

GENERAL ELECTRIC COMPANY

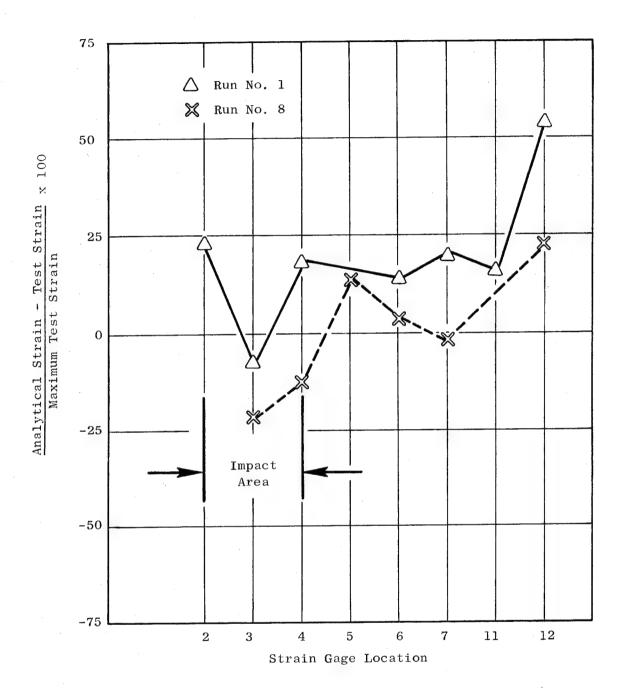
Figure 52. Analytical Strain Versus Test Strain Runs 1 and 8.

From Figure 52, it can be seen that, in general, the analytical and test data agree within +25 percent and -12 percent. The largest error occurred at gage location number 12 for both run 1 and run 8. One possible reason for this larger error at this location is the relatively coarse finite element model in the root area of the blade.

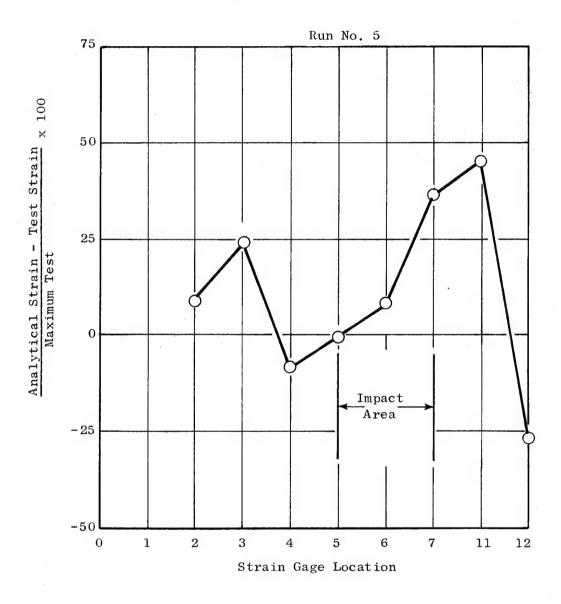
Figure 53. Analytical Strain Versus Test Strain Run 5.

The analytical versus test strain comparison for run number 5, shown in Figure 53, exhibits somewhat poorer agreement than for runs 1 and 8. This is a result of the fact that the impact occurred at 37 percent span, while the same bird properties (spring constant and damping characteristics) were used as had been used for the impacts at 75 percent span.

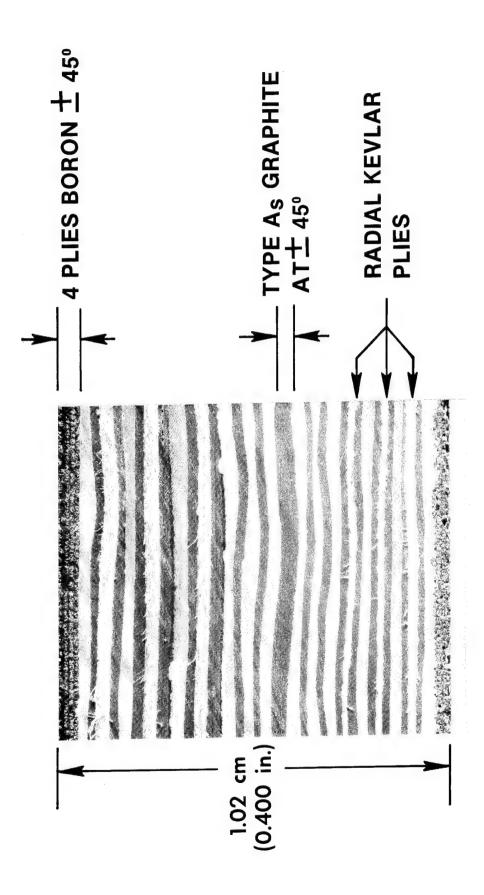
Figure 58. Cross Section of Test Panel Representing Current QCSEE Blade.

- 2. The panels containing Kevlar produced low short-beam shear and charpy values relative to the panels containing S-glass.
- 3. Replacing the untreated graphite (AU) with surface-treated graphite (AS) did not improve short-beam shear or charpy values when Kevlar was present; the Kevlar being the weak link.
- 4. The intraply hybrid panels (4, 5, 6) having a  $\pm 0^{\circ} \pm 35^{\circ}$  orientation have higher short-beam shear values than the comparable interply hybrid panel (3) having  $\pm 0^{\circ} \pm 45^{\circ}$  orientation. This is probably due to the lower ply orientation angle.
- 5. The panel with a high percentage of S-glass had the highest charpy value.
- 6. All three of the intraply panels had essentially the same properties.

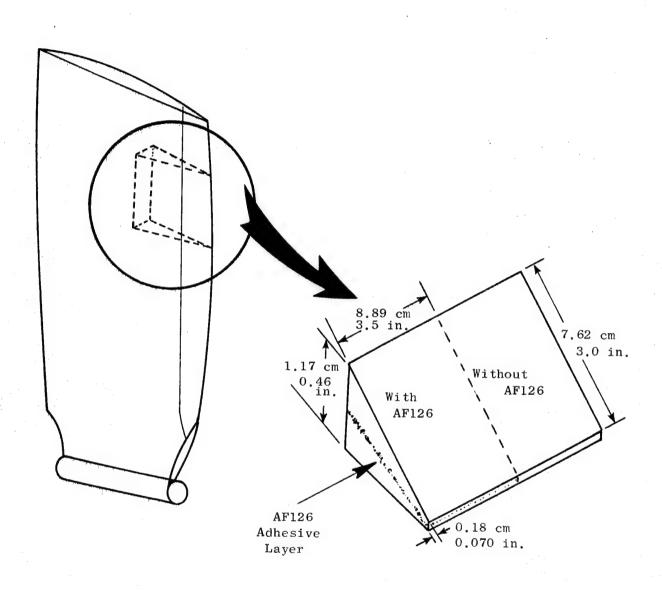
Figure 66. AF126 Adhesive Panel.

which exist in an actual blade and thereby to potentially improve the shear strength at this location. Short-beam shear specimens were tested at an L/d ratio of 5:1. The data showed no improvement in shear strength by using the AF126 layer; however, examination of the specimens revealed that failures occurred in the outer plies and not the center. The failures were of a tensile nature rather than shear. Additional specimens were then tested using L/d ratios of 3:1 and 2:1. After testing a single specimen at 3:1 and examining the specimen, the failure mode was still tensile. The remaining specimens were then tested at 2:1. Still, failure did not occur along the center plane and no differences were noted in test data values. In addition, due to the tapered nature of the specimens, testing of the specimens in the short-beam shear setup was difficult because the panel tended to slide when the load was applied. In view of the above difficulties, it was not possible to reach any definite conclusions relative to the adhesive core panel. In an actual blade with a complex molding, improvement by this technique might offer some advantages.

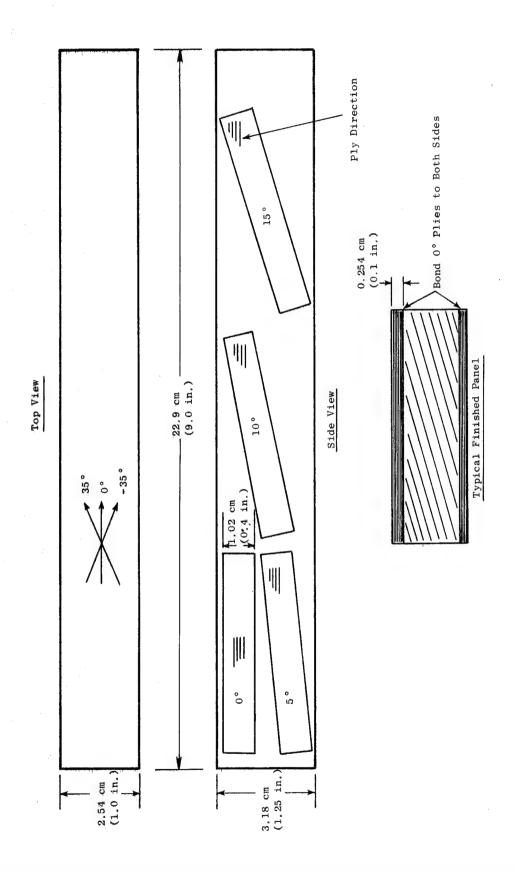
Figure 67. "Shingling" Radial Test Panel.

These results show that shingled angles do not significantly decrease or increase the shear strength of flat panels. Shingled plies however, may offer the potential for improved blade strength by eliminating the potentially weak center ply ends characteristic of conventional blade layups.

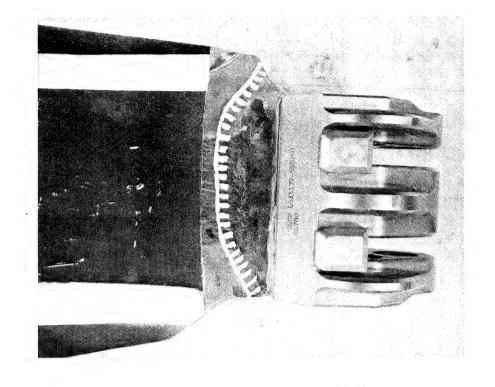
Figure 87. Pin Root Blade Root Delamination, Unbonded Area.

Before impact testing, the pin root blade was run up to 3800 rpm (117 percent of mechanical design), to demonstrate overspeed capability. Following this test, a delamination in the composite dovetail was detected. No damage was detected on previous runs at 3200 rpm. Figure 86 shows a photograph of the delamination at the leading edge using die penetrant. Figure 87 shows the extent of the delamination as defined by ultrasonic inspection; the area below the white ticked line representing the area of delamination. After a review of the extent of the delamination, it was decided to proceed with the impact test of the blade. Since the damage was confined to the root area of the blade, the ability of the airfoil portion of the blade to absorb the impact should be unchanged. Therefore, any impact advantage associated with the pin root concept could still be identified.

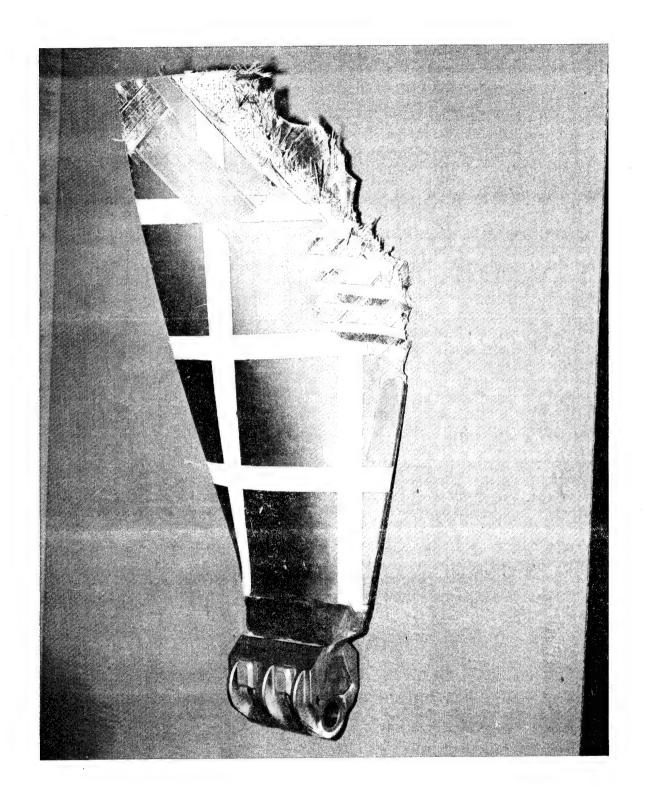
Figure 88. Pin Root Blade after Impact.

As can be seen from the figure, the pin root blade rotated to an initially higher angle than the keyhole blade, about 11 degrees versus five to six degrees. Also, the pin root blade rotation damped out much more slowly than the keyhole blade; this is due to the reduced friction associated with the pin. These data show that the pin root concept might be helpful for a particular blade design if the blade root was susceptible to root failure upon impact since the pin root has low resistance to rotation.

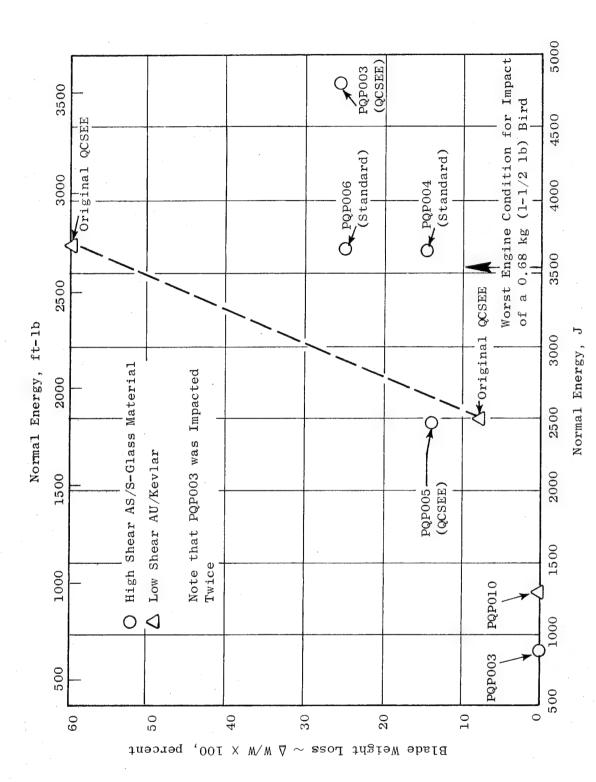
Figure 90. Blade Weight Loss for 75% Span Impact Tests.

present the weight loss and area delaminated in graphical form versus the normal energy parameter,  $E_{\rm N}$ , which is described in Sections 3.3 and 3.4. The results of testing on the original QCSEE blade in 1974 and the test conducted in conjunction with the pin root blade test are also shown for comparison. Note that blade PQP003 was also impacted with an 82 grams (2.9 ounce) slice. This was due to a malfunction in the injector mechanism, however, since the blade was not severely damaged, it was retested as shown. Also shown on Figures 90 and 91 is the normal energy at takeoff for a 0.68 kg (1-1/2 pound) bird impact. Photographs of the concave and convex side of each blade after impact are presented in Figures 92 through 99. Based on the data presented above, the following conclusions have been drawn:

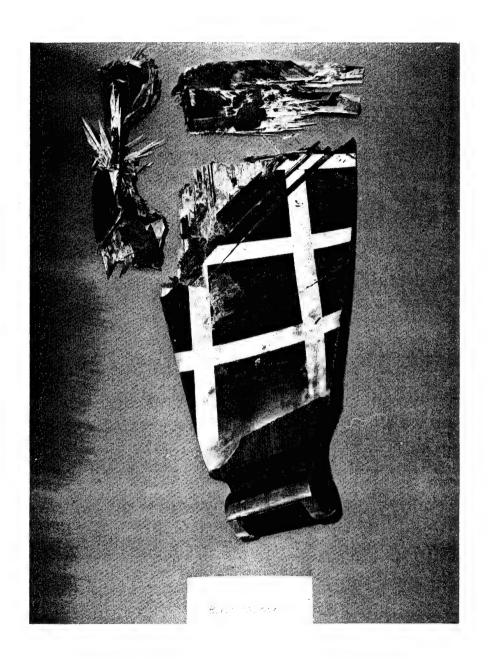
Figure 92. Blade PQP003 Concave Side after Impact.

The four improved blades were impacted at the same condition [33 degree incidence angle and 340 gram (12 ounce) slice weight] that resulted in serious damage to an early QCSEE blade, which had suffered over 60 percent weight loss and 100 percent airfoil delamination.

% Airfoil Area	Delaminated	10	81	89	76	99
	Percent Wt Loss	(%) M/M	0	26	15	14	25
ditions.	Original Blade Weight	15	5.31	5.31	5.31	5.37	5.37
Takeoff Engine Conditions.	Original E	kg	2.41	2.41	2.41	2.44	2.44
off Eng	Slice Wt	20	2.9	17.0	12.8	8.2	13.0
Take	Slic	8	82	482	363	232	369
		Blade	PQP003		PQP004	PQP005	PQP006

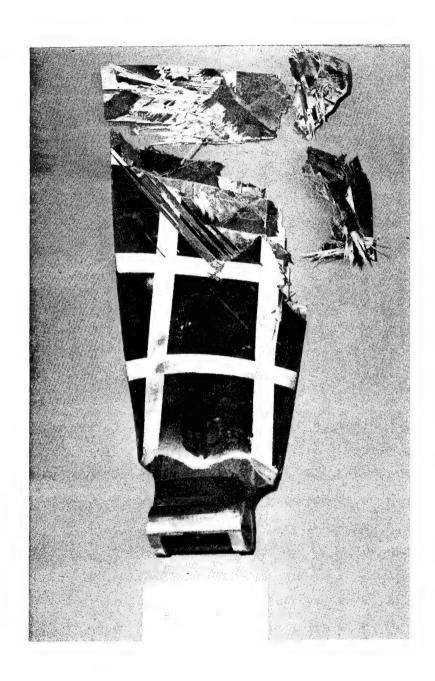
Figure 93. Blade PQP003 Convex Side after Impact.

- Observation of the failed blades suggests the standard-type layups PQP004 and 006 appear to lose a region at the leading edge tip when impacted, whereas blade PQP003, having the QCSEE design, lost the entire outer portion of airfoil. At lower span impacts, this characteristic of the QCSEE layup could result in worsened FOD capability relative to the standard layup.
